CIVIL AERONAUTICS BOARD

ACCIDENT INVESTIGATION REPORT

**CONTINENTAL CHARTERS, INC., NEAR LITTLE VALLEY, NEW YORK
DECEMBER 29, 1951****THE ACCIDENT**

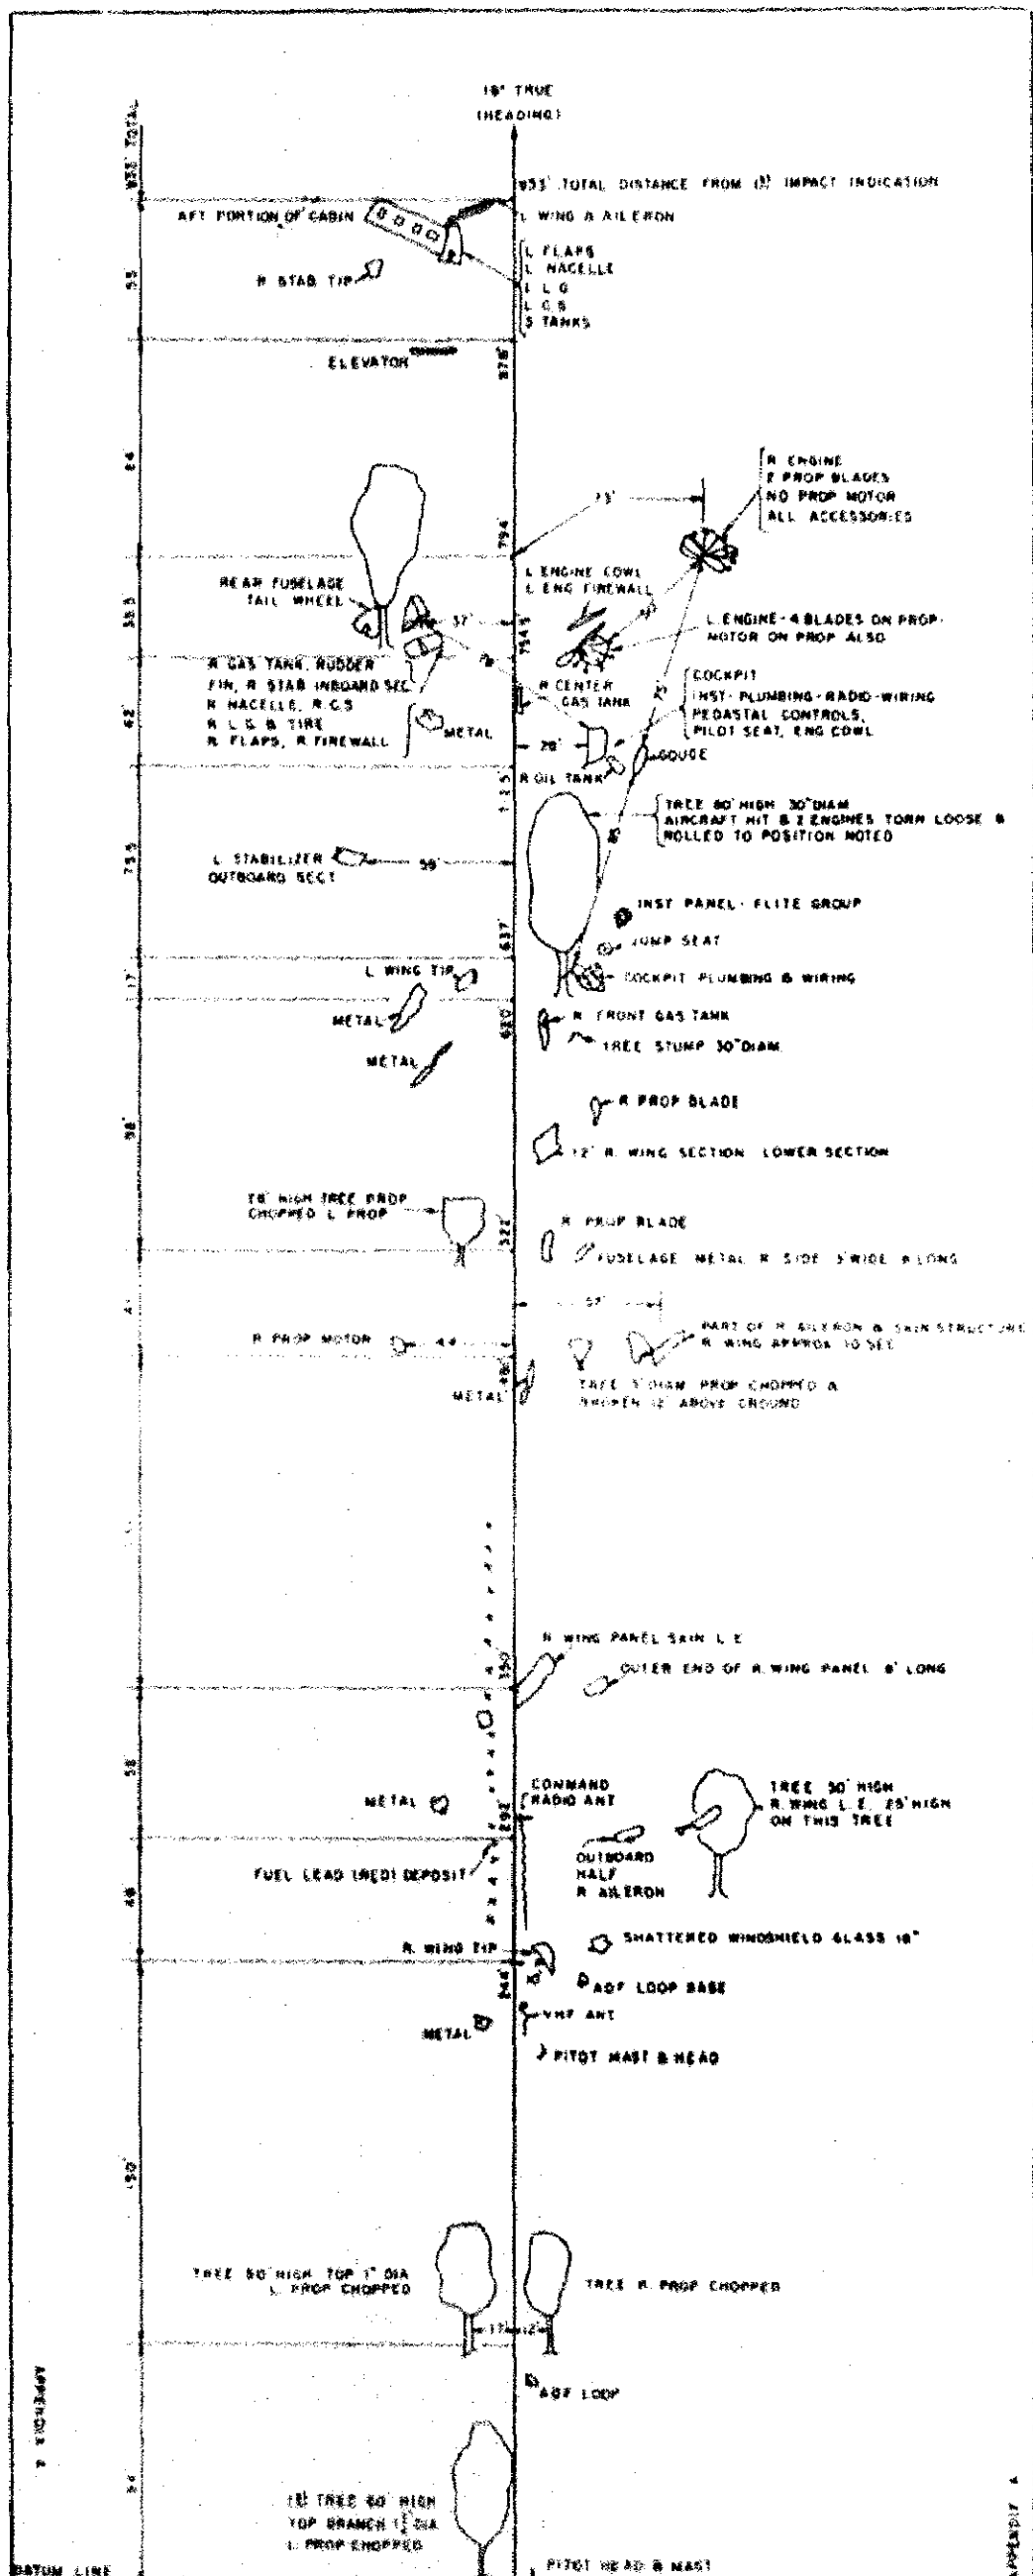
² See appendix "A" - Wreckage Distribution Chart

Investigation at the scene indicated that the accident occurred about 100 feet below the crest of a hill, at an altitude of 2375 feet MSL, while the aircraft was in level flight and on a true heading of approximately 18°. Indications were that first contact was with small branches of a tree 60 feet above the ground. From this point on, as forward travel continued, disintegration of the aircraft progressed along a path 933 feet beyond the point of initial impact. All major components were accounted for along this path. Disintegration of the aircraft was complete with the exception of the aft part of the passenger compartment which came to rest at the most distant end of the line of travel.² It was in this section that

all those who survived had been seated. Detailed examination of the wreckage disclosed no evidence of structural failure or mechanical malfunctioning of any part of the aircraft or its components. Both engines were developing appreciable power at impact, and both propellers were found in approximately the 30° setting, which is within the cruising range.

DISTRIBUTION OF AIRCRAFT WRECKAGE
ALL WRECKAGE SHOWN IS IN DENSE WOODED AREA
"DRAWING NOT TO SCALE"

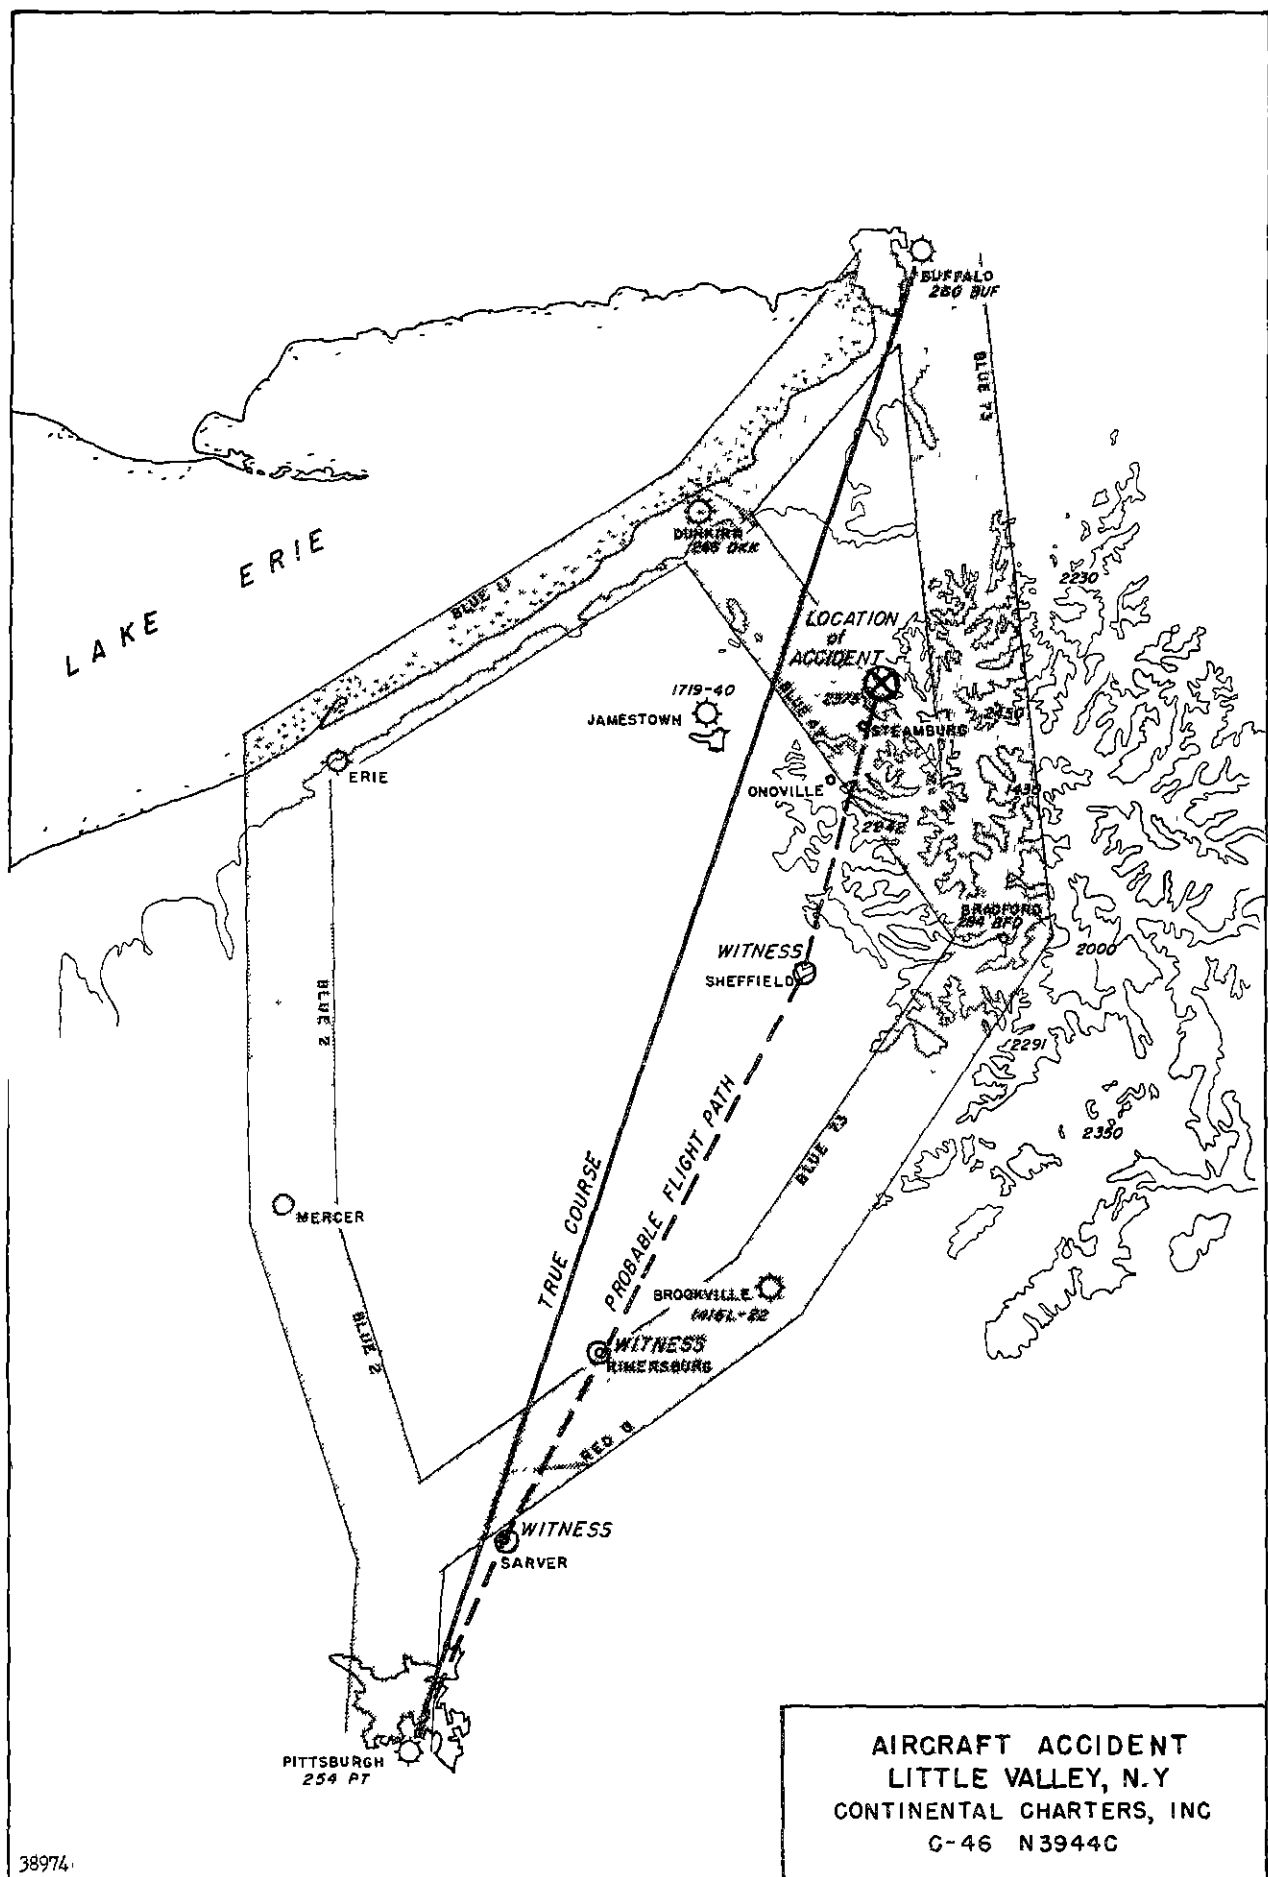
⁴ See Appendix B--Chart showing probable flight path

The direct course from Pittsburgh to Buffalo is 18° true. In its Flight Information Manual which was effective on December 29 1951, the Civil Aeronautics Administration classifies this area as mountainous terrain, requiring a VFR night flight to maintain an altitude of not less than 2,000 feet above the highest point within a horizontal distance of 5 miles either side of the center of a direct course. In non-mountainous terrain, an altitude of not less than 1,000 feet above the highest point is required for VFR night flight. The airport at Jamestown, New York, which lies at the extreme western edge of this area, has an elevation of 1,719 feet; the accident occurred about 12 miles east of the direct course in terrain which is considerably higher than that at

Jamestown.⁴ Continental Charters' operations over this route were being conducted on the premise that the terrain is not considered mountainous, further, the company had been so advised by the CAA Aviation Safety District Office, Miami, and the agent assigned to supervise Continental Charters' operations so testified at the public hearing on this accident.

Reports of ground observers and testimony of surviving passengers indicated that Flight 44-2 was conducted at a low altitude all the way from Pittsburgh to the accident scene. The first reliable indication of the flight's position after departing Pittsburgh was "very low" over Sarver, Pennsylvania, approximately 28 miles north-northeast of the Pittsburgh-Allegheny Airport and three miles east of the true course, Pittsburgh to Buffalo. The next position, Cowansville, Pennsylvania, approximately 40 miles north-northeast of Pittsburgh and eight miles east of the true course, was reported by ground observers who heard but did not see a low-flying aircraft. Following this a low-flying aircraft was reported to have been heard at Rumersburg, Pennsylvania, approximately 52 miles north-northeast of Pittsburgh and eight miles east of the true course. At Sheffield, Pennsylvania, approximately 104 miles north-northeast of Pittsburgh and 15 miles east of the true course, it was reported that an aircraft had been seen entering a fog bank. The next point along the intended course to Buffalo which provided reliable information as to the possible passage of Flight 44-2 was at Onoville, New York, about 13 miles south-southwest of the crash site and 11 miles east of the true course. Witnesses here, who stated that an aircraft flew over very low, described the weather as "foggy." Witnesses at Steamburg, New York, approximately seven miles south-southeast of where the accident occurred and on a direct course from Onoville to the crash site, stated that the aircraft flew over there exceptionally low, and three reported they could distinguish the lighted passenger compartment windows. They stated further that the weather was very foggy and estimated visibility as less than one-half mile. Steamburg is located in a valley 1,410 feet above
